ORIGINAL ARTICLE MR Imaging

Investigating MRI safety practices in Greece. A national survey

Nikolaos Stogiannos¹, Catherine Westbrook²

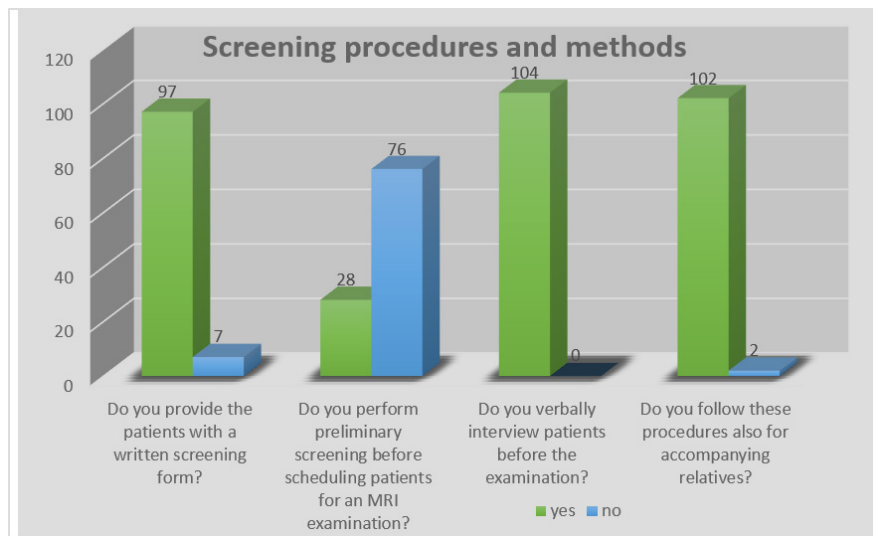
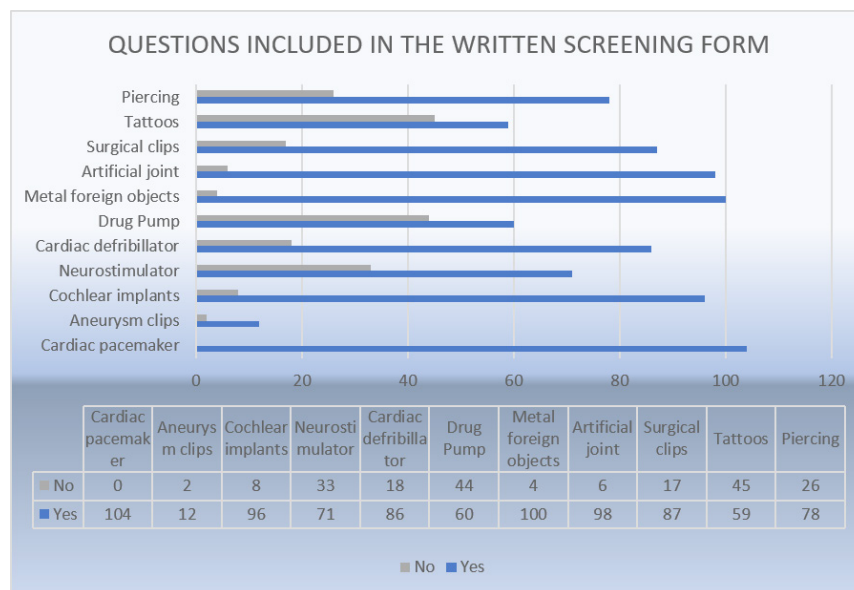
Fig. 2. a. Frequency distributions related to pre-MRI screening procedures and methods. **b.** Frequency distributions regarding the questions included in the pre-MRI screening form.

Regarding the pre-MRI written screening form, the vast majority of the responders answered positively. Specifically, 97 (93.3%) of the participants provide the patients with a written screening form. On the contrary, only 28 (26.9%) of the responders have implemented preliminary screening as a way of screening patients before scheduling them for MRI examinations (**Fig. 2a**).

Specific issues were also explored regarding the questions included in the written pre-MRI screening forms (**Fig. 2b**). The overall descriptive statistics for screening procedures and methods are shown in **Table 2**. Generally, most of the responders answered positively at a high percentage regarding the questions included in the written screening form. The only exceptions stand for

neurostimulators (71, 68.3%), implanted drug pumps (60, 57.7%) and tattoos (59, 56.7%), which in comparison were at a lower percentage.
